## Ironing out the wrinkles on metal roofs

Differential stress in the metal used in roofing and wall panels can cause a condition called stress wrinkling, or oil canning. New Millennium has a solution to help iron out this problem.

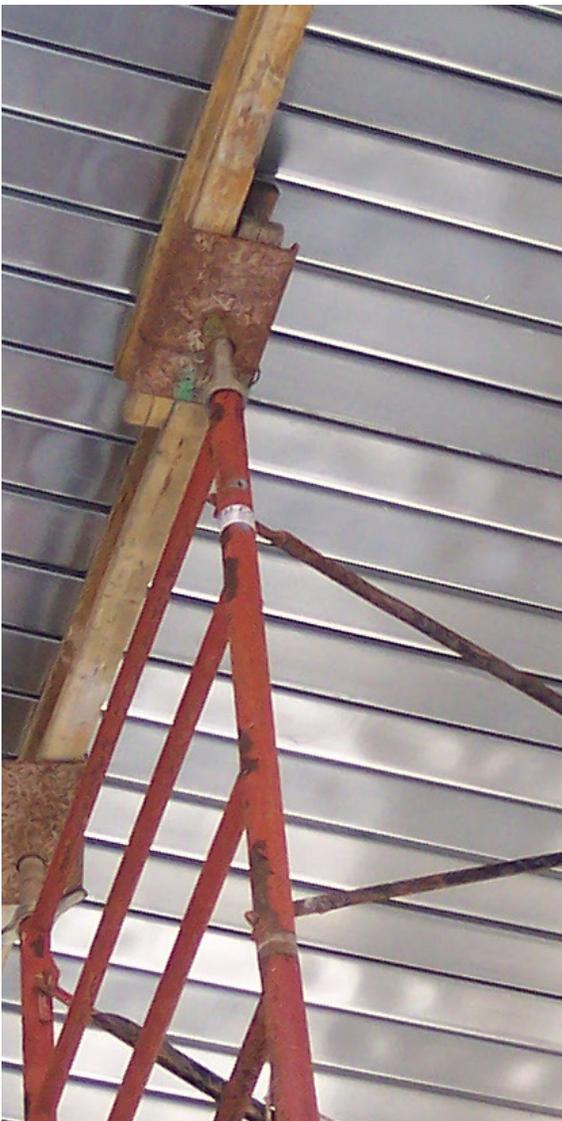
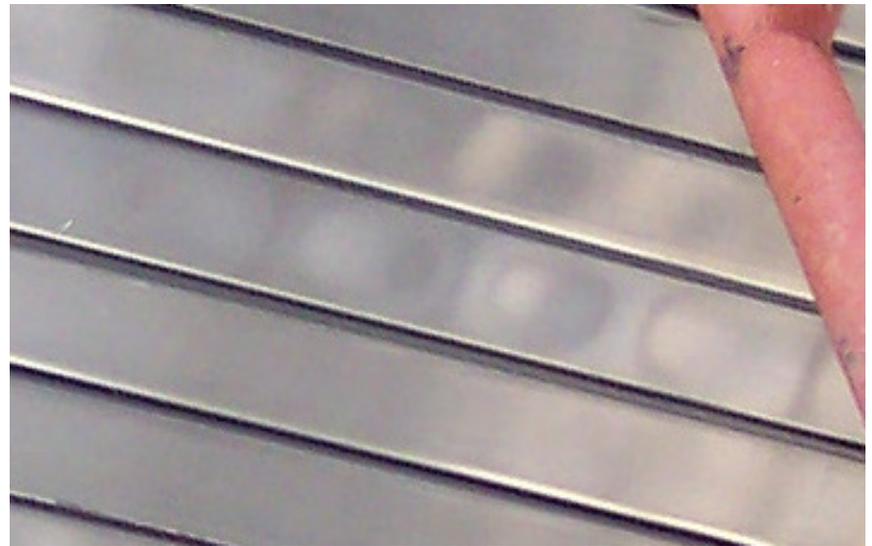
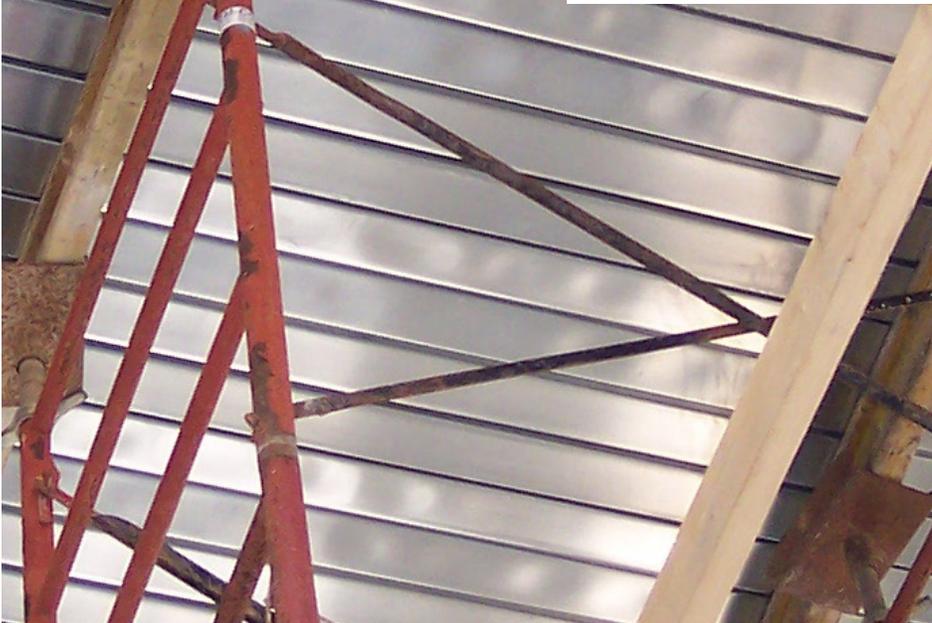
*As seen here, oil-canning, or stress wrinkling, is an unsightly problem associated with several different causes but avoidable with the use of longitudinal stiffeners*

Oil canning is visible waviness in the flat areas of metal roofing and wall panels seen when light hits the metal just right. The condition — also known as “stress wrinkling” and “elastic buckling” — is a construction headache.

The introduction of intermediate longitudinal stiffeners can help minimize oil canning and improve the structural effectiveness of the stiffened flange when compressed.

"Our 3.5-inch-deep Versa-Dek® 3.5 LS and 2-inch-deep Versa-Dek® LS ES have small longitudinal stiffeners in the middle of relatively wide bottom flanges that help us to reduce oil canning," says Vitaliy Degtyarev, Design and Research Engineer for New Millennium Building Systems. "This is true for acoustical, non-acoustical, composite, and roof profiles. The stiffeners help us achieve greater section properties in the negative bending, when the bottom flange is in compression."
